TECHNICAL DATA SHEET

FS1.0205 - Carriage motor group FS1 "CENTO"

Spring to control belt tension

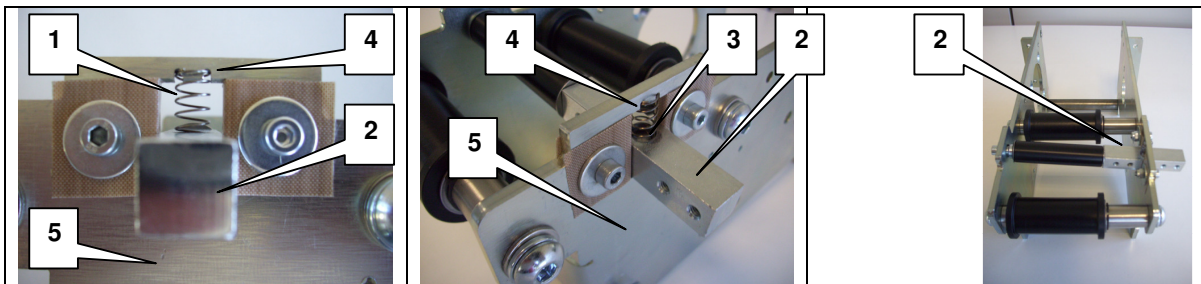
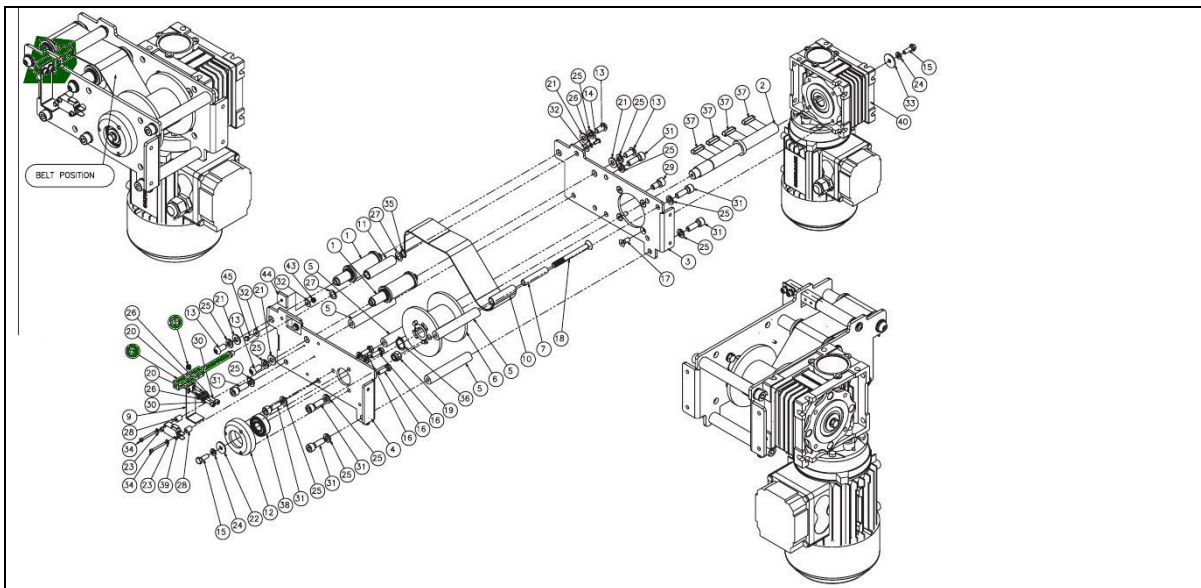
We have added a spring (1) N2.5159 on the shaft (2) FS1.2057 to ensure, that in case the belt FS1.2065 will loses tension the machine will created an alarm and stops operation. It has been noticed that without spring (1), it could happen that the shaft (2) doesn't activate the sensor N5.2375 and thus doesn't make the alarm. To keep the spring in position an extra hole (3) has been made in the shaft (2) and two extra guides (4) have been cut out from the plate (5) FS1.2044

The modification has been made on all FS1 "CENTO" machines supplied after **15-05-2012**
For older versions pay additional attention during maintenance on this specific point.
